CHAPTER G-2 GATES OTHER THAN RADIAL GATE

G-2.2 Description of Gate Types and Potential Failure Modes

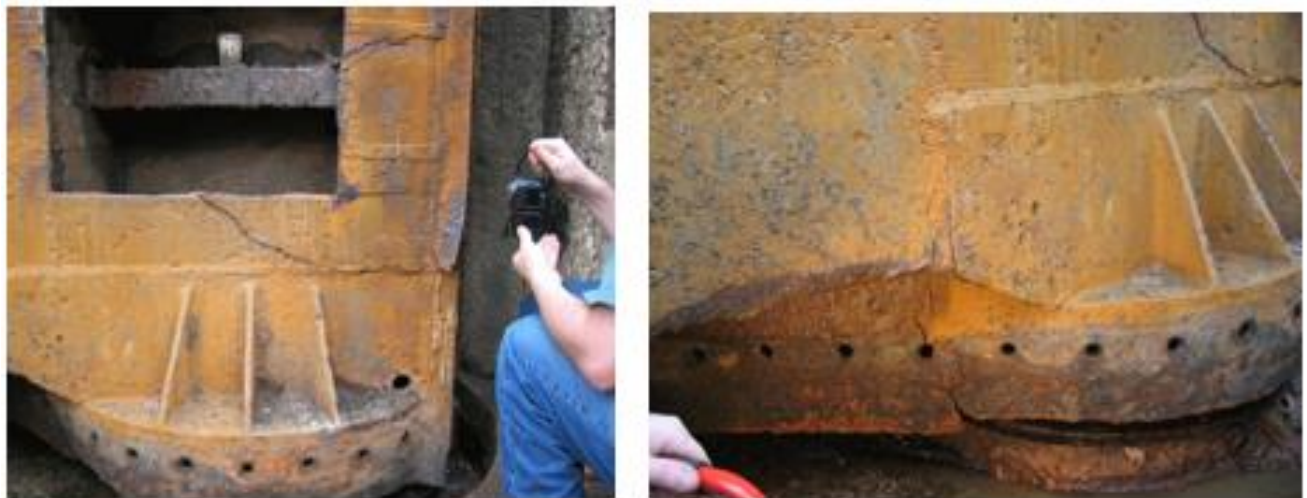
Figure G-2-8 Cracking in Main Chamber Miter Gates, Greenup Lock and Dam (USACE, May 2010)

Cracking has also been found in the flanges where the pintle casting is connected or in the pintle socket casting itself. Cracking in the flanges can cause excessive movement of the pintle, which could result in problems during operation of the gates. Cracking of the pintle socket casting is usually caused by worn or improper adjustment of quoin blocks resulting in loss of contact with the wall quoin. This results in additional load on the pintle, which can lead to cracking of the pintle or failure of the bolts at the girder connection (USACE, June 2010). Figure G-2-8 shows cracking around the pintle casting discovered at Greenup Locks and Dam in September 2003.

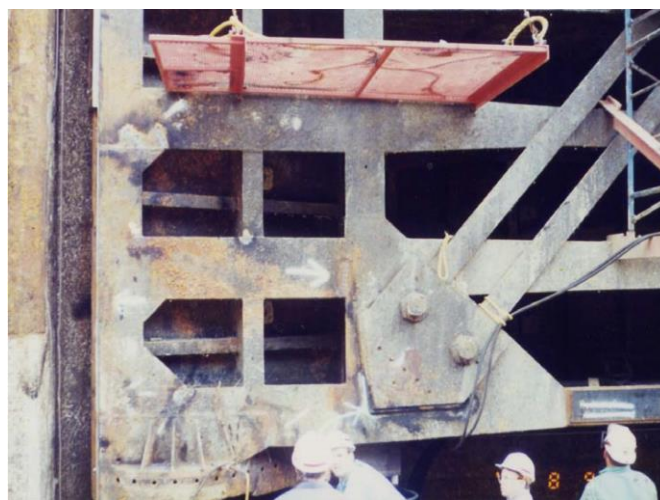
Figure G-2-12 Fatigue cracking in girder flange at diagonal anchor plate, Markland Lock and Dam (USACE, June 2010)

A dewatering was scheduled for the main chamber at Markland Locks and Dam in 1994 to perform major maintenance including jacking the miter gates and replacing the pintle and seals. Once the lock was dewatered and the gates were inspected, severe cracking was found in some of the welds of the horizontal girders. In particular, the heaviest cracking occurred near the pintle area on the lower girders. It was determined that the extensive cracking was fatigue-related and additional finite element analysis was done to help determine the cause for the extensive cracking. Through the additional analysis, it was determined that the cracking was due to residual tensile stresses present near the girder welds. When welding occurs during original construction, large stresses are developed in the members near the weld joints. During operation of the gate, the members are subjected to compression loads, causing a stress reversal at these locations. Since the gates were considered to be in critical condition, immediate repairs were made to the gate during the dewatering. This included gouging out the cracks and rewelding. To evaluate the performance of the repairs, another dewatering was scheduled in 1996. It was found that the cracks had re-initiated at the same locations where they had been repaired during the 1994 dewatering. Other modifications were made to the gate during the dewatering of 1996 including adding structural plates, etc, but the condition of the gate was still considered critical. Louisville District Operations and Engineering Divisions instituted a 2-3 year dewatering interval to continue to monitor the gates until the gates were replaced (USACE, 1999).

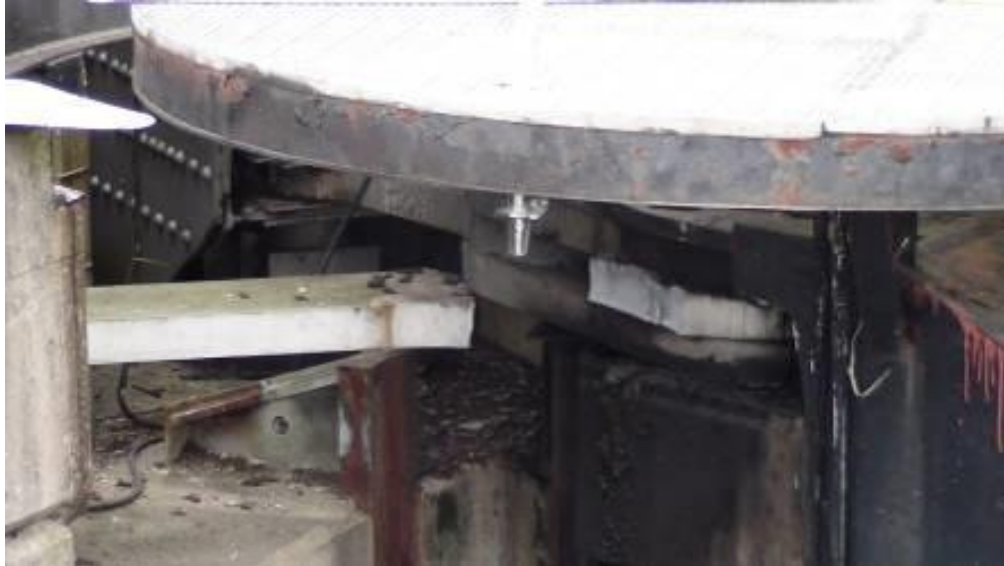
Figure G-2-13 Failed Anchor Arm, Greenup Lock and Dam (USACE, May 2010)

The emergency closure of Greenup Locks and Dam main chamber took place from Wednesday, 27 January through Monday, 22 February 2010. The closure resulted from a sudden fatigue failure of the miter anchor arm on the main chamber downstream middle wall gate leaf. The gate was being properly operated during a routine up bound lockage. No operator error occurred. The failure initiated at the root of a fillet weld connecting the miter anchor arm to the top connecting link and propagated through the entire cross section of the miter anchor arm. The weld was shown on the original contract drawings and had been identified during Periodic Inspection No. 8 performed in July 2008 as a poor weld detail for a tension member. Visual inspection of the root of the weld and base material subsequent to failure indicates the crack had initiated prior to the failure as evidenced by corrosion in the crack. The crack was not visible during prior inspections due to limited accessibility, paint and over spill of lubricating grease for the gudgeon pin.

The gate came to rest on the concrete sill in a near vertical position supported by the pintle, strut arm and the remaining non fractured but damaged recess anchor arm. Emergency repairs were performed on January 29, 2010 by welding a splice plate to the fractured anchor arm and other gate stabilization efforts were completed to prevent more damage to the gate. The miter gate was removed and a detailed structural inspection was performed on the gate and anchorage. Dive inspections were performed on the gate sill and pintle. Anchor wedge assemblies, anchor arms, connector plates, gudgeon and link pins were replaced and the gate was reinstalled on February 21, 2010. A final inspection was done on February 22, 2010 and the main lock chamber was reopened for traffic (USACE, May 2010).

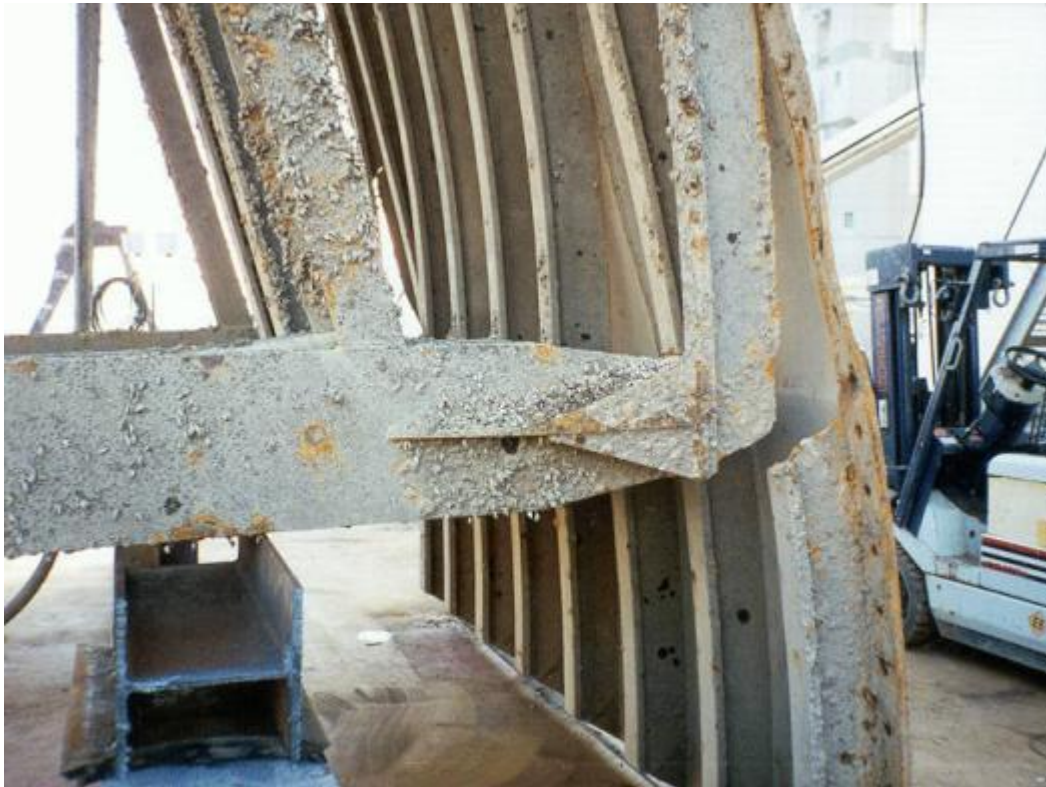
Figure G-2-14 Failed Culvert Valve, Cannelton Locks and Dam

The lower river wall emptying culvert valve for the main chamber at Cannelton Locks and Dam was reported to be inoperable on September 10, 1999. The valve emergency bulkheads were set by lock personnel, but extensive leakage prohibited immediate dewatering of the valve chamber. The Louisville Repair Station (LRS) arrived at the site early in the week of 4 October and were able to get the bulkheads set and the chamber pumped down so that the valve could be inspected and removed for repairs. The initial inspection was performed on Wednesday, 6 October 1999. The valve was inspected in-situ in the valve chamber. The valve was bound against the sidewalls and had a slight twist in a clockwise direction as viewed facing downstream. The skin plate and vertical rib beams were torn away from the lower girder. The fillet welds that attached the rib beams to the lower girder had failed. The second and third vertical rib beams were fractured completely through the flange and extended through the web, and proceeded to tear the stem of the T-beam away from the skin plate. These beams had also broken loose from the upper girder. The end vertical rib beam nearest the Kentucky side suffered a fractured web. The downstream flanges of both of these girders experienced warping when the rib beams tore away. The culvert valve was removed and inspected more closely and it was found that the main valve body was considered structurally sound and deemed capable of service. The failure of the valve may be attributed to fatigue of the welds which connect the rib T-beams to the lower girder beam of the

main valve frame. Cannelton's 1200 foot chamber has experienced a significant number of open/close cycles in its 30 year career; this is categorized as low cycle fatigue loading. In addition to the low cycle static loading imparted by differential hydraulic head, the valve also experienced high cycle fatigue due to turbulent flow conditions (USACE, October 1999).

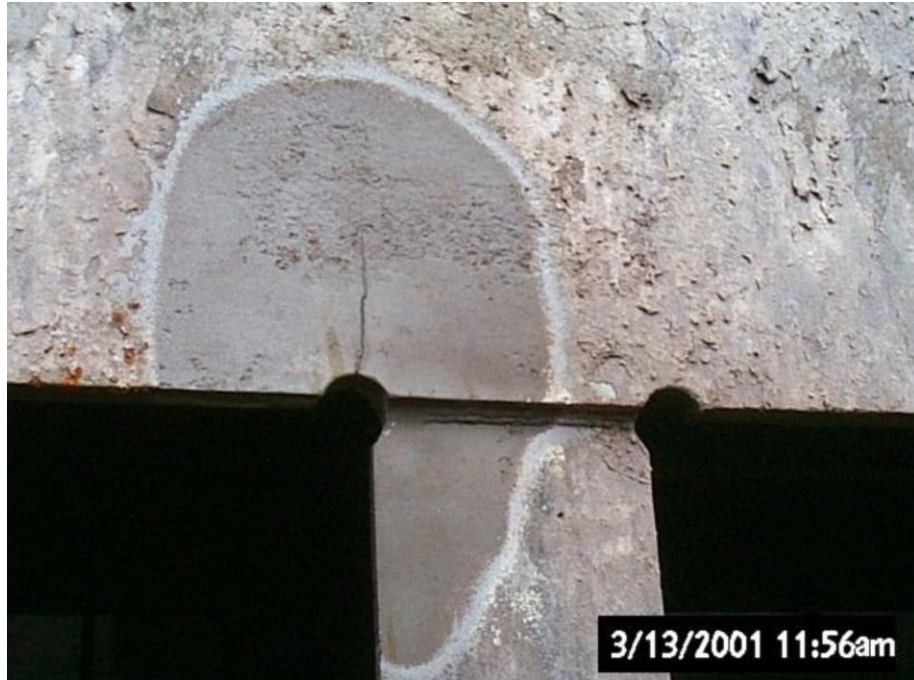
Figure G-2-16 Fatigue Cracking in Tension Tie, Vertical Lift Gate, John Day Locks and Dam (Hanson & Chambers, 2001)

The downstream lock gate at John Dam lock and Dam is a vertical lift gate 88 feet wide and 113 feet high. The gate was placed in service in 1963 and was exposed to full pool starting in 1968. The gate has exhibited cracking problems of welds and members since 1982. Maintenance of the gate and crack repair has been ongoing at periodic intervals since cracking was first observed. In the periodic inspection conducted in 1994 a significant number of large cracks were noticed at locations where welds were placed in the tension tie, in particular at the welded connections between the bracing and the tension tie and in the tension tie connection to the compression member at the vee joint. Because of the concern generated by the reemergence of the cracks,

additional analysis was performed using finite element analysis, calibrated with strain gauges on the gate. The contractor was asked to evaluate the condition of the gate, estimate the remaining service life and develop possible modifications to extend the life of the gate. Based on the finite element analysis results it was determined that the cracking in the steel tension ties was caused by cyclic stress which exceeded the fatigue limit of the steel material at the welded connections. Fatigue sensitive weld details and poor weld quality contributed to failures early in the expected life of the lift gate (USACE, 1995) . The gate remained in service through maintenance and repairs until 2011 when the gate was replaced at a cost of 12 million dollars. The gate at John Day was modeled after the gate design for the vertical lift gate at Ice Harbor Locks and Dam. The gate at Ice Harbor was placed in service in 1962 and cracking was first discovered in 1980. Fatigue cracking at Ice Harbor lead to gate replacement in 1996 with a 2 month construction outage and a cost of 6.5 million dollars (Hanson & Chambers, 2001).

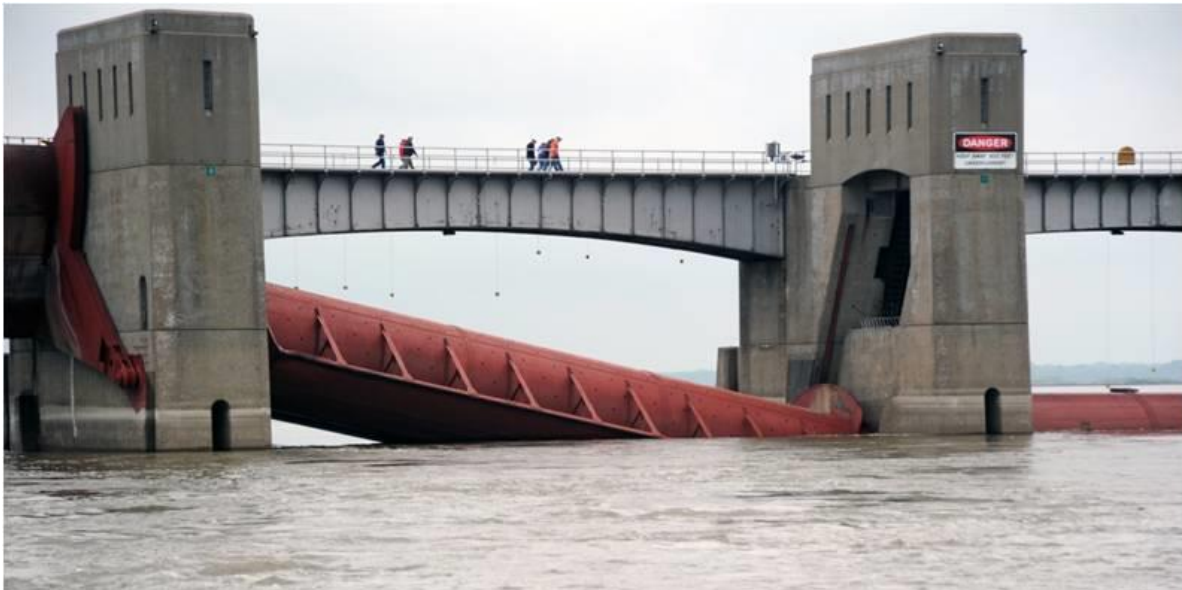
Figure G-2-17 Damaged Roller Gate, Mississippi River Lock and Dam 25 (USACE, Lock and Dam Maintenance Workshop 2011)

The emergency repair of a roller gate at Mississippi River Dam 25 took place as a result of an incident in April 2010. The incident resulted from a limit switch failure. During a routine gate raising operation as the river was rising to a level in which all gates were being fully raised, the upper limit switch gear of one of the project's three 109-foot long roller gates moved out of its shaft, which prevented it from turning. As a result, the chain hoisted the gate all the way up to the point at which the hoist chain connection was ripped out of the gate, resulting in heavy damage to no fewer than five chain lug plates. It was believed that no operator error occurred.

The gate came to rest at an angle with the cog/hoist end up into the bottom of the machinery house. Emergency repairs began immediately by installing emergency stoplogs to stop flow. Damage was severe enough that engineers decided the gate had to be completely removed in order to implement complete repairs. Removing the gate required multiple attempts with various rigging arrangements. The clear distance from pier to pier is 100 feet; with a gate length of 109 feet, the gate would not clear the pier house. This was the first time a roller gate had ever been

removed from a USACE dam. The gate was repaired on a special work barge. During repairs it was discovered that over six feet of mud had accumulated inside the roller gate body; this was removed. Because both side shields were damaged during the failure, each had to be removed and replaced with new custom fabricated replacements, as well as the chain lug plates. To facilitate re-installation, approximately 30 feet of the apron had to be temporarily removed. The fully repaired gate was successfully reinstalled by the summer of 2010. (USACE, Lock and Dam Maintenance Workshop 2011).
